Massachusetts Energy Code Pilot Report

July 5, 2011

NMR Group, Inc.

KEMA, Inc.

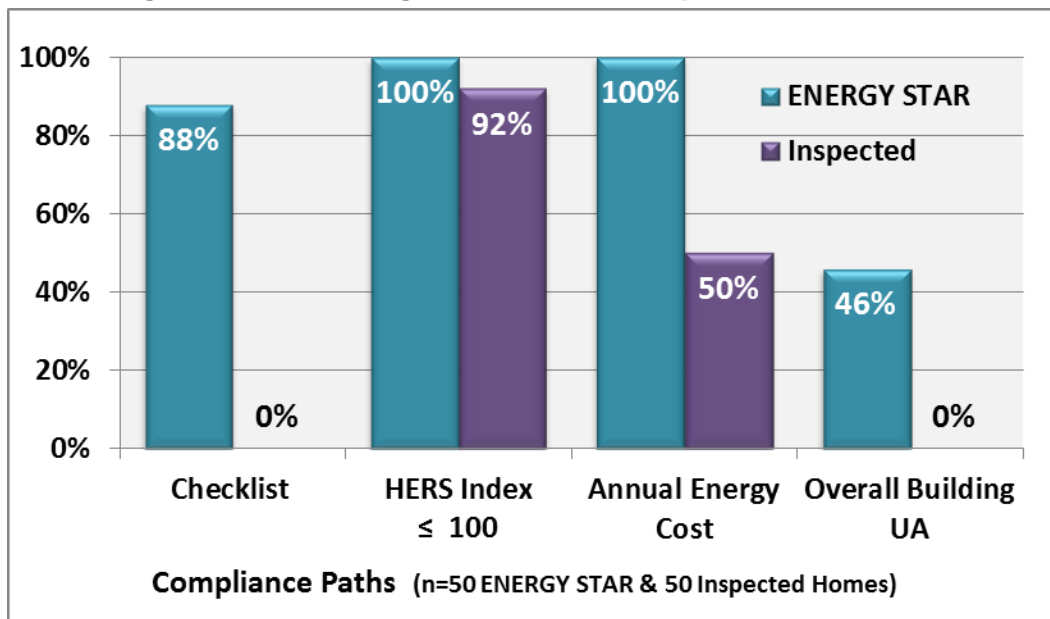
Figure 7-1: Percentage of Homes in Compliance—All Paths²⁴

Figure 7-1 shows a comparison of compliance results for the ENERGY STAR and non-ENERGY STAR (inspected) homes. This figure displays the percentage of homes that were in compliance using each of the four compliance paths. Across the board ENERGY STAR homes displayed a higher overall compliance than inspected homes. The two samples were most similar, in terms of compliance, when assessed using the Home Energy Rating compliance path; under this path 100% of the ENERGY STAR homes and 92% of the non-ENERGY STAR homes were compliant.

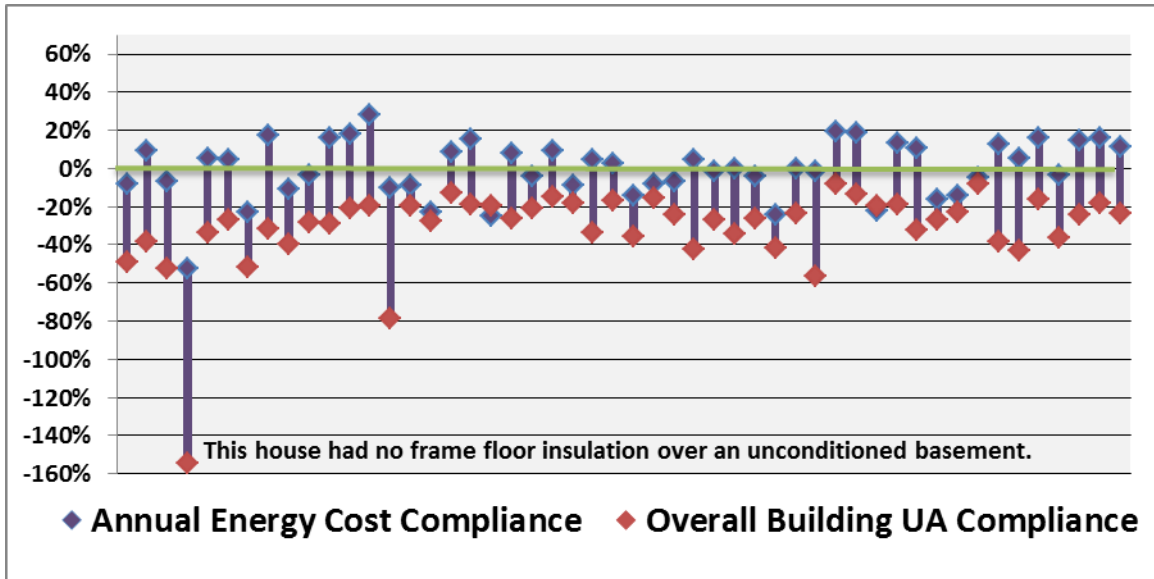
Figure 7-3: Comparison of Annual Energy Cost and Overall Building UA Compliance—Inspected Homes

Similar to what was shown in Figure 7-2, Figure 7-3 shows a comparison of compliance rates under the Annual Energy Cost and Overall Building UA trade-off approaches for the 50 inspected homes. The same trends hold true for the inspected homes; there is a wide variation in individual home compliance when comparing the two compliance paths. As was true for the ENERGY STAR homes, the Annual Energy Cost compliance path showed greater compliance than the Overall Building UA trade-off approach for all 50 inspected homes.

For both samples, the 50 ENERGY STAR homes and the 50 non-ENERGY STAR homes, the trends between the Annual Energy Cost and the Overall Building UA trade-off compliance paths hold true. In short, there is considerable variability between individual Annual Energy Cost compliance and Overall Building UA trade-off compliance paths. Both samples also show a fair amount of variability across all 50 homes, with some homes being significantly above or below code and others just meeting code.
